National Aerospace Laboratory NLR

NLR-TP-2002-289

# **Material-based failure analysis of a helicopter rotor hub**

A Lynx helicopter from the Royal Netherlands Navy lost a rotor blade during preparation for take-off. The blade loss was due to failure of a rotor hub arm by fatigue. The arm was integral to the titanium alloy rotor hub. An extensive material-based failure analysis covered the hub manufacture, service damage and estimates of service stresses. There was no evidence for failure owing to poor material properties. However, fractographic and fracture mechanics analyses of the service failure, a full-scale test failure and specimen test failures indicated that the service fatigue stress history could have been more severe than anticipated. This possibility was subsequently supported by a separate investigation of the assumed and actual fatigue loads and stresses.

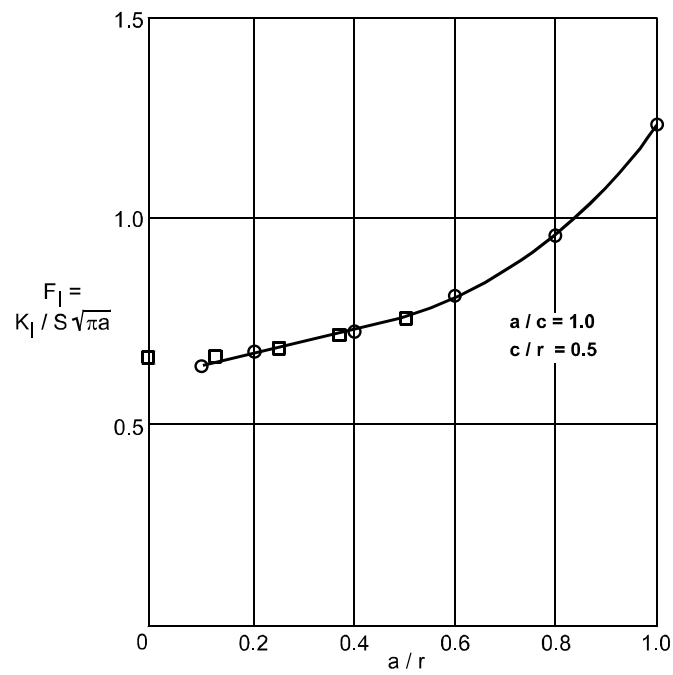
Since the specimens were cylindrical, the fracture roughness transition boundaries approximated to the configuration of semi-elliptical cracks in round bars. There is no straightforward stress intensity factor solution for this configuration, but Murakami's Handbook [11] gives functional relationships for certain values of  $a/c$ ,  $a/r$  and  $c/r$ , where  $a$ ,  $c$  and  $r$  are shown in figure 8. The Handbook results closest to the configurations in figure 8 are summarised in figure 9, where we assume  $a/c = 1$ . The actual  $a/c$  values were 1.15, 1.23 and 1.29, but there are no Handbook data for  $a/c > 1$ . We assume further that the dimensionless stress intensity factors,  $F_1$ , in figure 9 apply to the specimen crack sizes and shapes at the fracture roughness transition boundaries. Interpolation of the functional relationship in figure 9 then gives the results in table 5. The constancy of the  $K_{\max,T}$  values in table 5 is evidence for fracture mechanics control of the roughness transition boundaries.

Fig. 9 Dimensionless stress intensity factors,  $F_I$ , at point A (see figure 8) for semi-elliptical cracks in tension-loaded round bars. After Murakami [11]

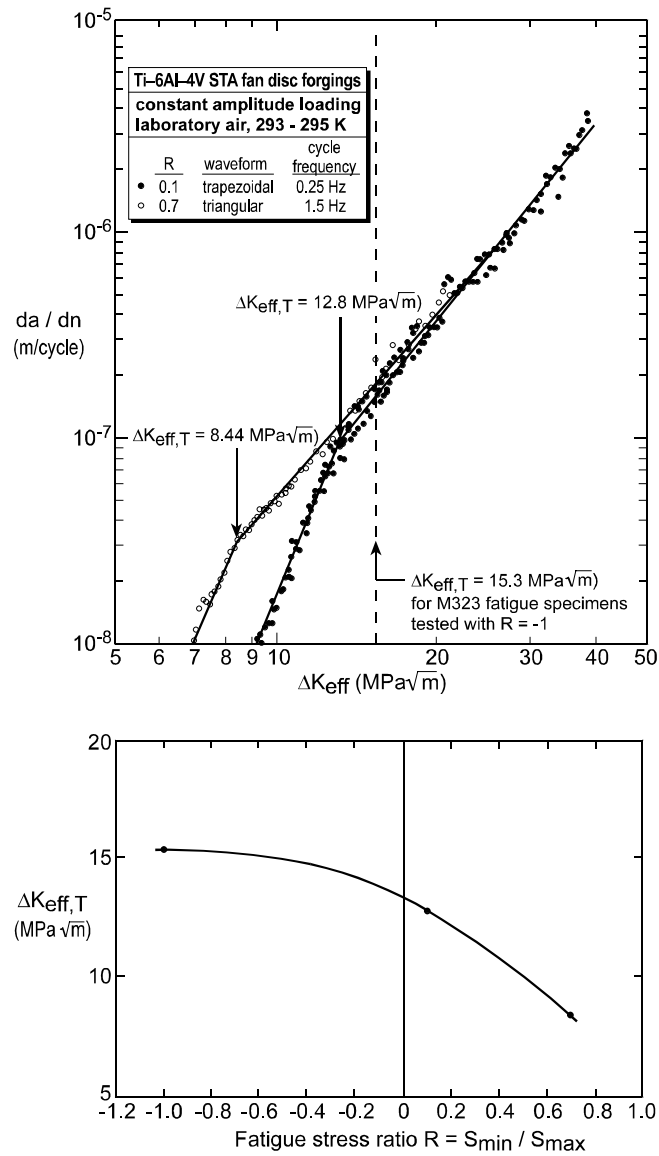
Further necessary information is obtainable by converting  $K_{\max,T}$  to  $\Delta K_{\text{eff},T}$ . This may be done using equation (7) and taking the specimens'  $R$  value of  $-1$ . The average result is  $\Delta K_{\text{eff},T} = 15.3 \text{ MPa}\sqrt{\text{m}}$ . Figure 10 compares this result with  $\Delta K_{\text{eff},T}$  values obtained for similarly processed Ti-6Al-4V [9]. From what is generally known about stress ratio effects on fatigue crack growth

rates (see e.g. Newman [10]), figure 10 shows a plausible functional dependence of  $\Delta K_{\text{eff},T}$  on  $R$ . The consequences of this plausibility are twofold:

Although point (b) might seem problematical, figure 10 shows there is little change in  $\Delta K_{\text{eff},T}$  over a wide range of negative  $R$ . Returning to the question of stress ratio differences discussed for the Method (I) modified estimates, from figure 10 we obtain  $\Delta K_{\text{eff},T}$  values of  $15.3 \text{ MPa}\sqrt{\text{m}}$  and  $15.0 \text{ MPa}\sqrt{\text{m}}$  for  $R = -1.14$  and  $R = -0.59$  respectively. This difference in  $\Delta K_{\text{eff},T}$  values can be neglected in the present context of service stress level estimates.

- (1) The fracture roughness transition boundaries for the M323 service failure and fatigue specimens are due to the same mechanism.
- (2) The  $\Delta K_{\text{eff},T}$  versus  $R$  relationship in figure 10 is valid for the M323 fatigue specimens and service failure: in the latter case specifically with respect to  $(S_{a,mfo})_{M323}$  for the fatigue origin location.
- (3) For the M323 service failure we may use the approximate stress intensity factor for a semi-circular surface crack in a thick plate [12]:

We use equation (11), the  $\Delta K_{\text{eff},T}$  versus  $R$  relationship in figure 10, and equation (7) to derive  $\Delta K_{\text{eff},T}$ ,  $S_{\text{max}}$ ,  $S_{\text{min}}$ , and  $(S_{\text{max}} - S_{\text{min}}) / 2 = (S_{a,\text{mfo}})_{\text{M323}}$  for selected values of  $R$ , see table 6. As discussed earlier, it is likely that the M323 fatigue origin  $R$  value was much less negative than  $R = -1$  and possibly the same as that for the M6 fatigue origin, i.e.  $R = -0.59$ . On this basis, table 6 indicates a reasonable estimate of  $(S_{a,\text{mfo}})_{\text{M323}} = 372$  MPa.

Fig. 10 Functional dependence of  $\Delta K_{eff,T}$  on  $R$ . The fatigue crack growth data are from Wanhill and Looije [9]
